**Flood Control Project Maintenance
Levee Inspections**

Fall 2012 Levee Maintenance Deficiency Summary Report

**Flood Control Project Maintenance
Levee Inspections****LMA District Cover Sheet
Fall 2012 Levee Inspection Results****Solano County Public Works Mellin Levee**

Solano County Public Works Mellin Levee

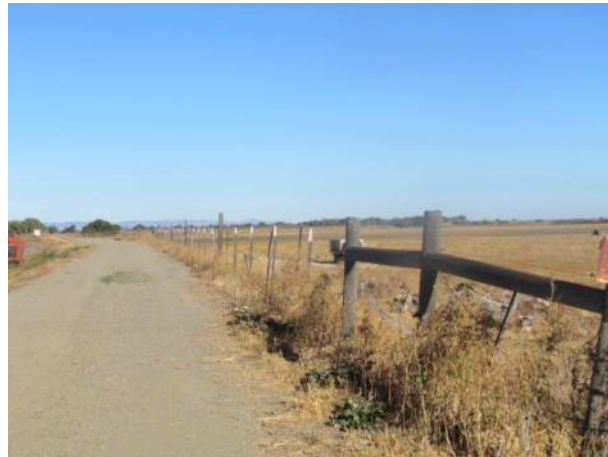
Levee Mile Report Line	6
Start Levee Mile	0.00
End Levee Mile	0.59
Location	Water Side
Category	Earthen Levee
Item	Encroachments

Looking west at fence on waterside shoulder.

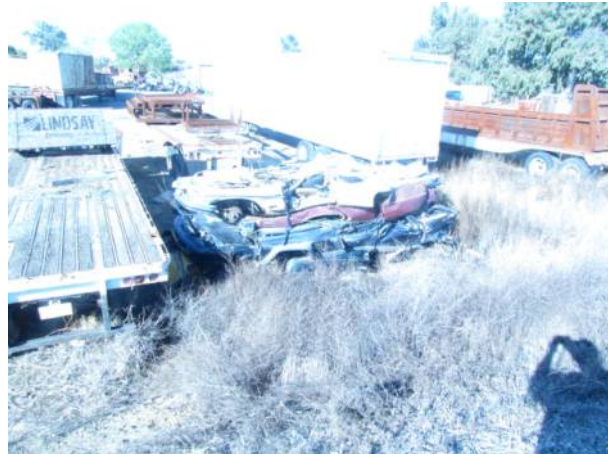
Levee Mile Report Line	7
Start Levee Mile	0.04
End Levee Mile	0.04
Location	Land Side
Category	Earthen Levee
Item	Encroachments

Looking south at crushed vehicles at landside toe.(Spring 2012)
